the obvious choice

EFFLORESCENCE, SALT CRYSTALLISATION & LIME STAINING – CAUSE & EFFECT

A LOOK AT SOME OF THE DIFFERENT FLOORING MATERIALS AND CONSTRUCTIONS USED OVER THE YEARS

‘ROMAN’ CEMENT – SOMETHING THE ROMANS DIDN’T DO FOR US!

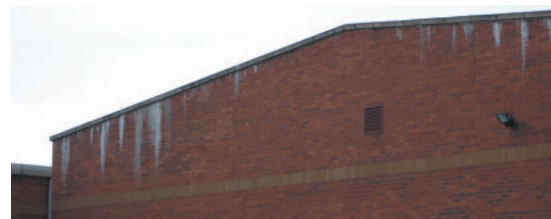
*Characteristic lime staining 'runs' from mortar joints*

Lime staining/weeping usually forms at mortar joints and mostly involves a similar mechanism to lime bloom, with lime leaching out as calcium hydroxide in instances where water is free to pass through areas of a structure. Calcium carbonate crystals form on the joint and often leach further over brick or masonry to appear as white 'runs' extending from the joint. This staining will not weather away naturally and requires application of a hydrochloric acid based cleaner to remove it. It is important to understand the mechanisms nature and cause of each of the above to prevent damage, re-occurrence and, where necessary, allow selection of appropriate cleaning/ remedial measures.

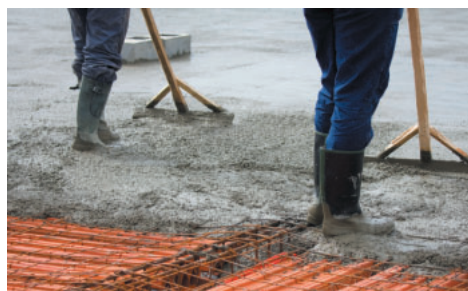
Placing an in-situ reinforced concrete floor

Many houses built in the 19th century had carpeted timber or tiled floors although brick floors were used in some instances. Timber floors continued to be used but the late 19th and early 20th centuries saw the emergence of reinforced concrete for solid ground bearing and suspended floor construction in commercial/industrial buildings and domestic housing.

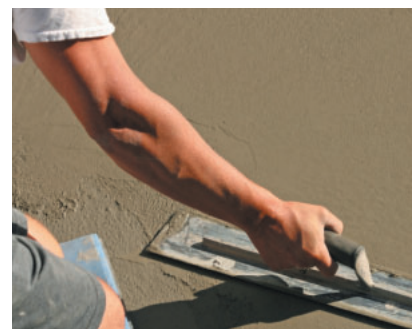
Float finishing a cement sand screed

Reinforced concrete floors may receive a power float finish, alternatively a cement/sand screed layer may be applied. This may be laid in a number of ways:

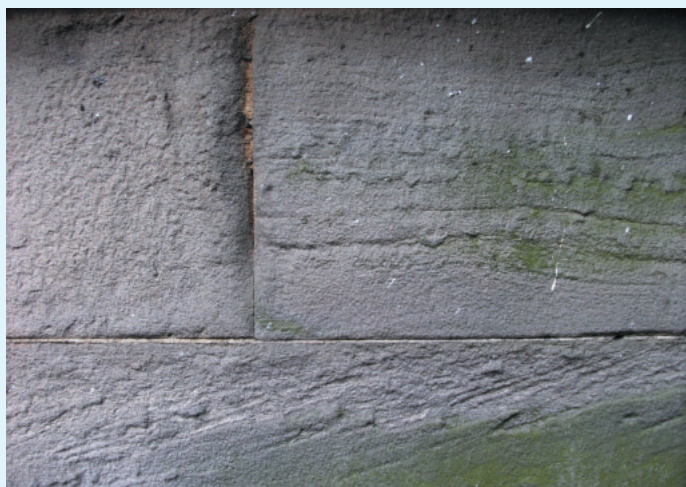
Sedimentary structures on show at Derby Cathedral

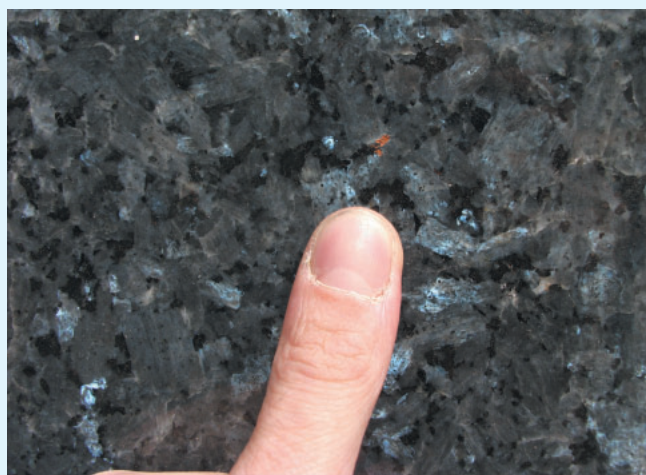
Larvikite is a very popular decorative stone, there is certainly plenty of it on display, and is probably the most recognisable of fascia rocks predominantly due to its pleasing and shiny aesthetic nature – however, there are several variations. The large

feldspar crystals (porphyry) make it obvious to even the youngest of (enforced) geologists as to what they are. The crystals can be highly variable too, as crystallisation of all ternary end-member feldspars (albite, anorthite and orthoclase) all occur at the same time in the magmatic melt. Indeed some of the crystals are so large other minerals can be seen between the laths of the feldspar crystals (see picture). The crystals in the rock have certain lustre, not bad for just less than 300 Million years old. The lustre is due to the Schiller effect - where the nature of the crystals allow light to reflect differently in certain planes - due to the alternation of the laths within the crystals between orthoclase and alkali feldspar provided by exsolution and prompting this perthitic texture. The rock also contains quartz or nepheline ± olivine ± Ti-poor augite ± hornblende ± ilmenite ± magnetite ± apatite ± zircon ± biotite.

This monzonitic rock originates from Scandinavia (the Larvik Pluton Complex) that was emplaced into upper crustal Palaeozoic bedrock during the Permian period. The extrusion allowed the pluton to remain in not only dry but also within reducing conditions thus helping to limit any interaction with the country rocks. A whole tale of magmatic evolution is there to be unfolded by the geologist. (Petersen, 1978). The Larvik complex is some 1000km² in plan and contains at least 10 singular plutons (Peterson, 1978) and as I stand here in
